Manhole Inspection Summary

Manhole # S31SS_014MH

Insp Date: **5/1/07 10:24 AM**

Location Address: **500 HAMDEN AVE**

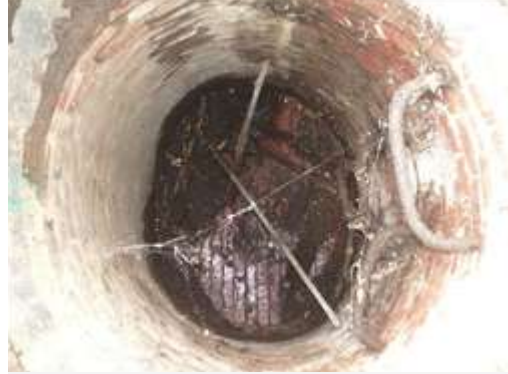
Top View

☒ **Debris** (not Condition related)

Steps Count: **5** Missing: **0** ☒ **Corroded**

Corroded steps. Channel debris.

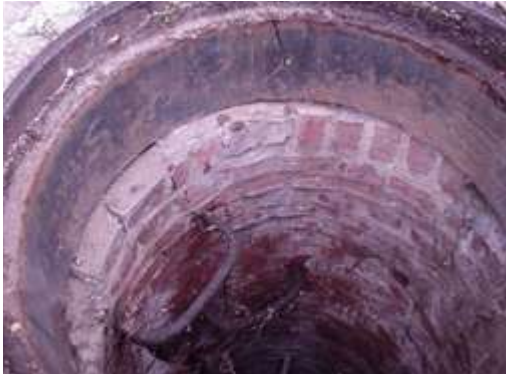
Defect

Frame Offset: **1** (in.)

☒ **Leaks**

Condition: ☐ Sound ☐ Cracked ☐ Root Intrusion ☐ Loose Brick ☒ **Deteriorated**

Infiltration: ☐ None ☒ **Joint** ☐ Cracks ☒ **Mortar** ☐ Roots ☐ Wall

Infiltration: ☐ None ☐ Joint ☐ Cracks ☒ **Mortar** ☐ Roots ☒ **Wall**

Frame leaks. Frame offset. Adjustment deterioration and infiltration. Corbel and Barrel infiltration.

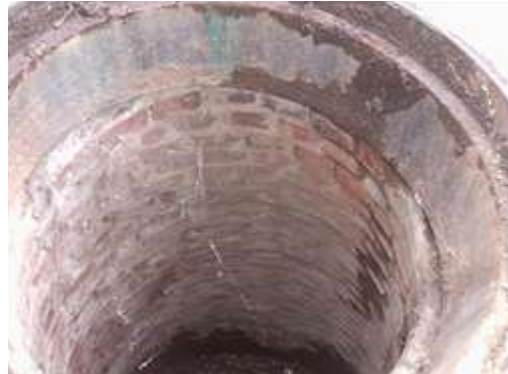
Defect

Frame leaks. Adjustment deterioration and infiltration. Corbel and Barrel infiltration.

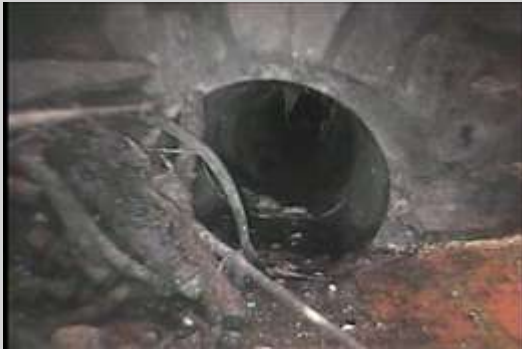
8 in. Circular Gravity Sewer
Pipe Out @ 12 O'Clock

Deposits: ☐ None ☒ **Mud** ☐ Sludge ☒ **Debris** ☐ Grease

Silt Depth: **0.5** (in.) Deposits Extent: **Light**
